Manhole Inspection Summary

Manhole # S23K__060MH

Insp Date: **6/16/08 8:42 AM**

Location Address: **317 S Mount St**

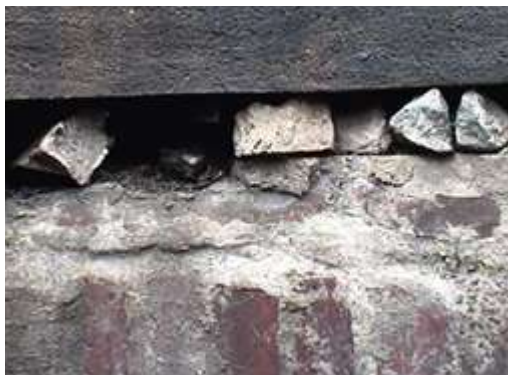
Misc 4

loose bricks missing mortar and bricks

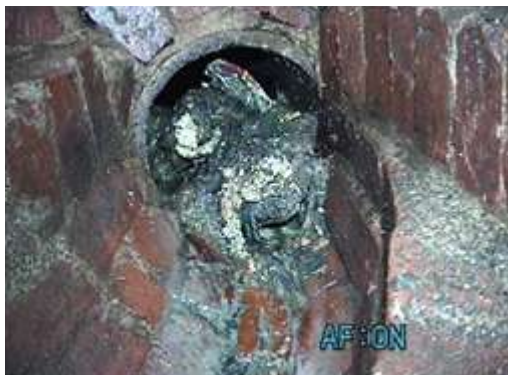
Defect 4

Condition: ☐ Sound ☐ Cracked ☐ Root Intrusion ☐ Deteriorated ☐ Leaks ☒ **Debris**

channel debris

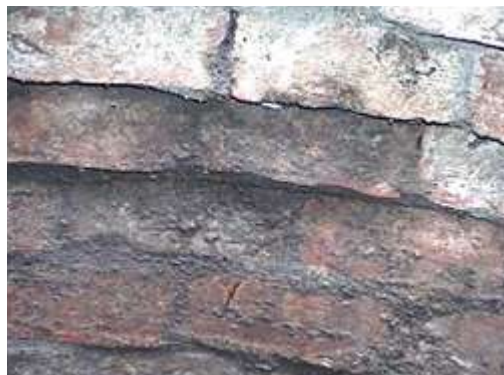
Defect 3

Condition: ☐ Sound ☒ **Cracked** ☐ Root Intrusion ☐ Loose Brick ☐ Deteriorated

Infiltration: ☐ None ☐ Joint ☐ Cracks ☒ **Mortar** ☐ Roots ☐ Wall

cracked corbel, infiltration corbel at mortar

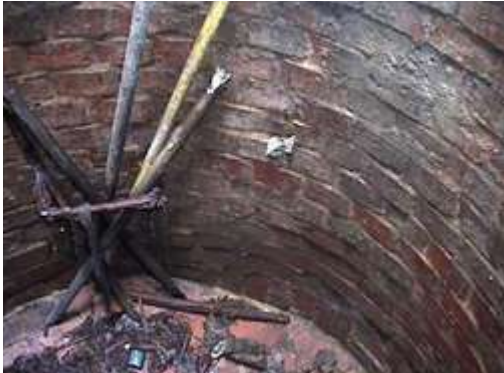
Defect 2

Condition: ☐ Sound ☐ Cracked ☐ Root Intrusion ☐ Deteriorated ☐ Leaks ☒ **Debris**

debris on bench and in between rungs

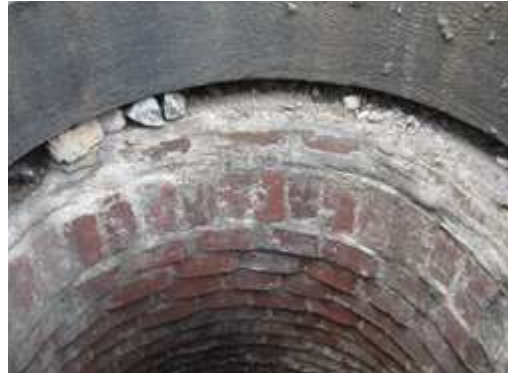
Defect 1

Frame Offset: **0** (in.) Condition: ☐ Sound ☐ Cracked ☒ **Leaks**

Condition: ☐ Sound ☐ Cracked ☐ Root Intrusion ☒ **Loose Brick** ☒ **Deteriorated**

Infiltration: ☐ None ☐ Joint ☐ Cracks ☒ **Mortar** ☐ Roots ☐ Wall

chimney cond loose bricks & deteriorated with signs of infiltration at mortar, frame leaks

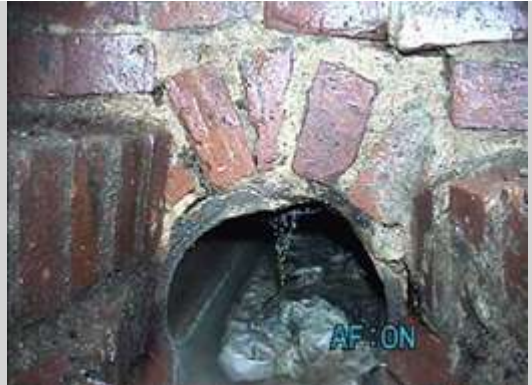
12 O'Clock Outflow

Pipe Height: **8.4** (in.) Rod and Bar (Angled)
Pipe Material: **Clay** ☐ Pipe Lined
Invert Depth: **10.27** (ft.) Flow Characteristics: **Slow**
Deposits: ☐ None ☐ Mud ☐ Sludge ☒ **Debris** ☐ Grease
Silt Depth: **2** (in.) Deposits Extent: **Medium**
Infiltration: **None** Pipe Seal Cond: **Sound**

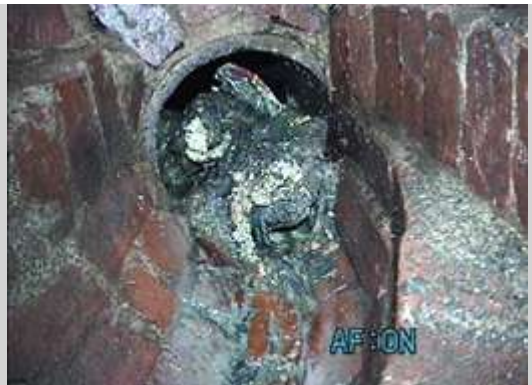
3 O'Clock Inflow

Heavy debris extending out of connection

Pipe Height: **7.2** (in.) Rod and Bar (Angled)
Pipe Material: **Clay** ☐ Pipe Lined
Invert Depth: **9.72** (ft.) Flow Characteristics: **Slow**
Deposits: ☐ None ☐ Mud ☐ Sludge ☒ **Debris** ☐ Grease
Silt Depth: **7** (in.) Deposits Extent: **Heavy**
Infiltration: **None** Pipe Seal Cond: **Sound**
